# The Hubble Space Telescope Optical Systems Failure Report

November 1990

National Aeronautics and  
Space Administration

**THE HUBBLE SPACE TELESCOPE**  
**OPTICAL SYSTEMS FAILURE REPORT**

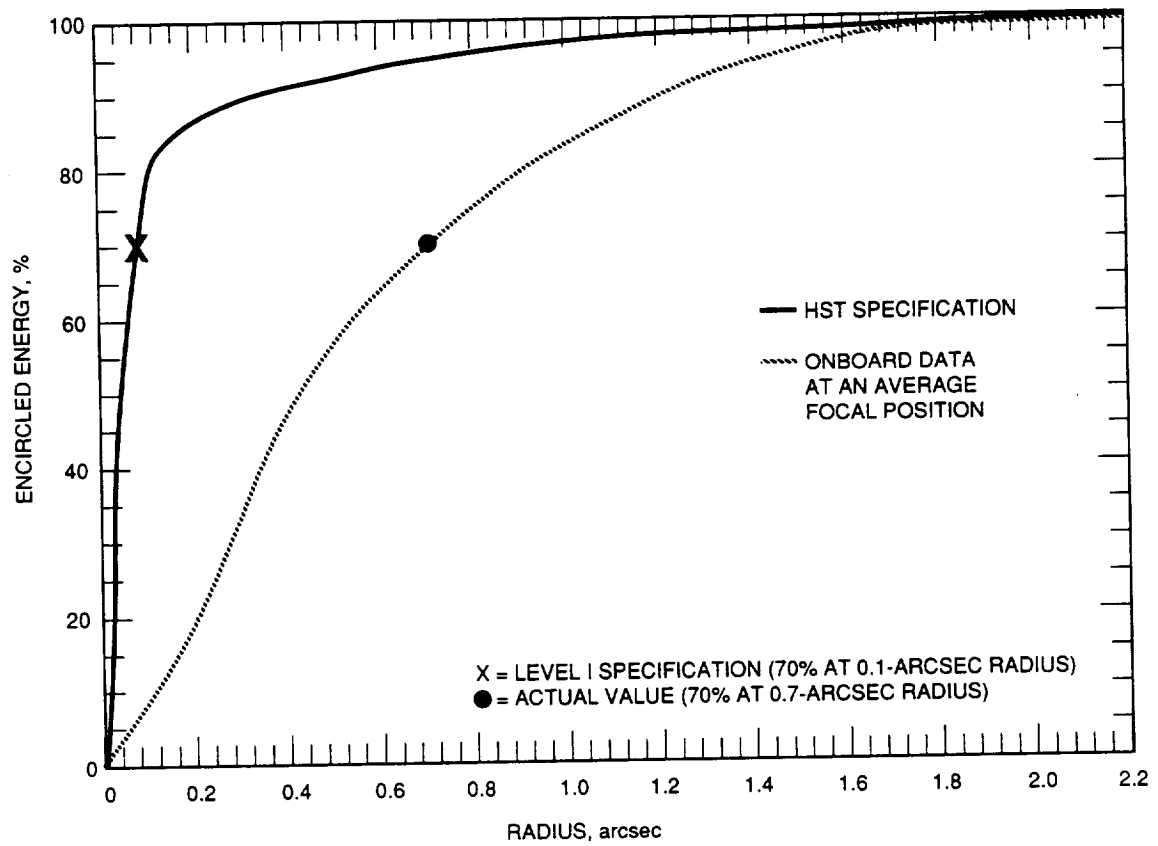
Spherical aberration distorts a point source image (e.g., a distant star) by broadening the image and surrounding it with concentric diffraction rings. This broadening effect prevents distant, closely spaced objects from being separated in the image. A tutorial on spherical and coma aberration is given in Appendix C.

**Figure 5-1. Encircled energy versus arcsecond radius of image produced by the HST.**

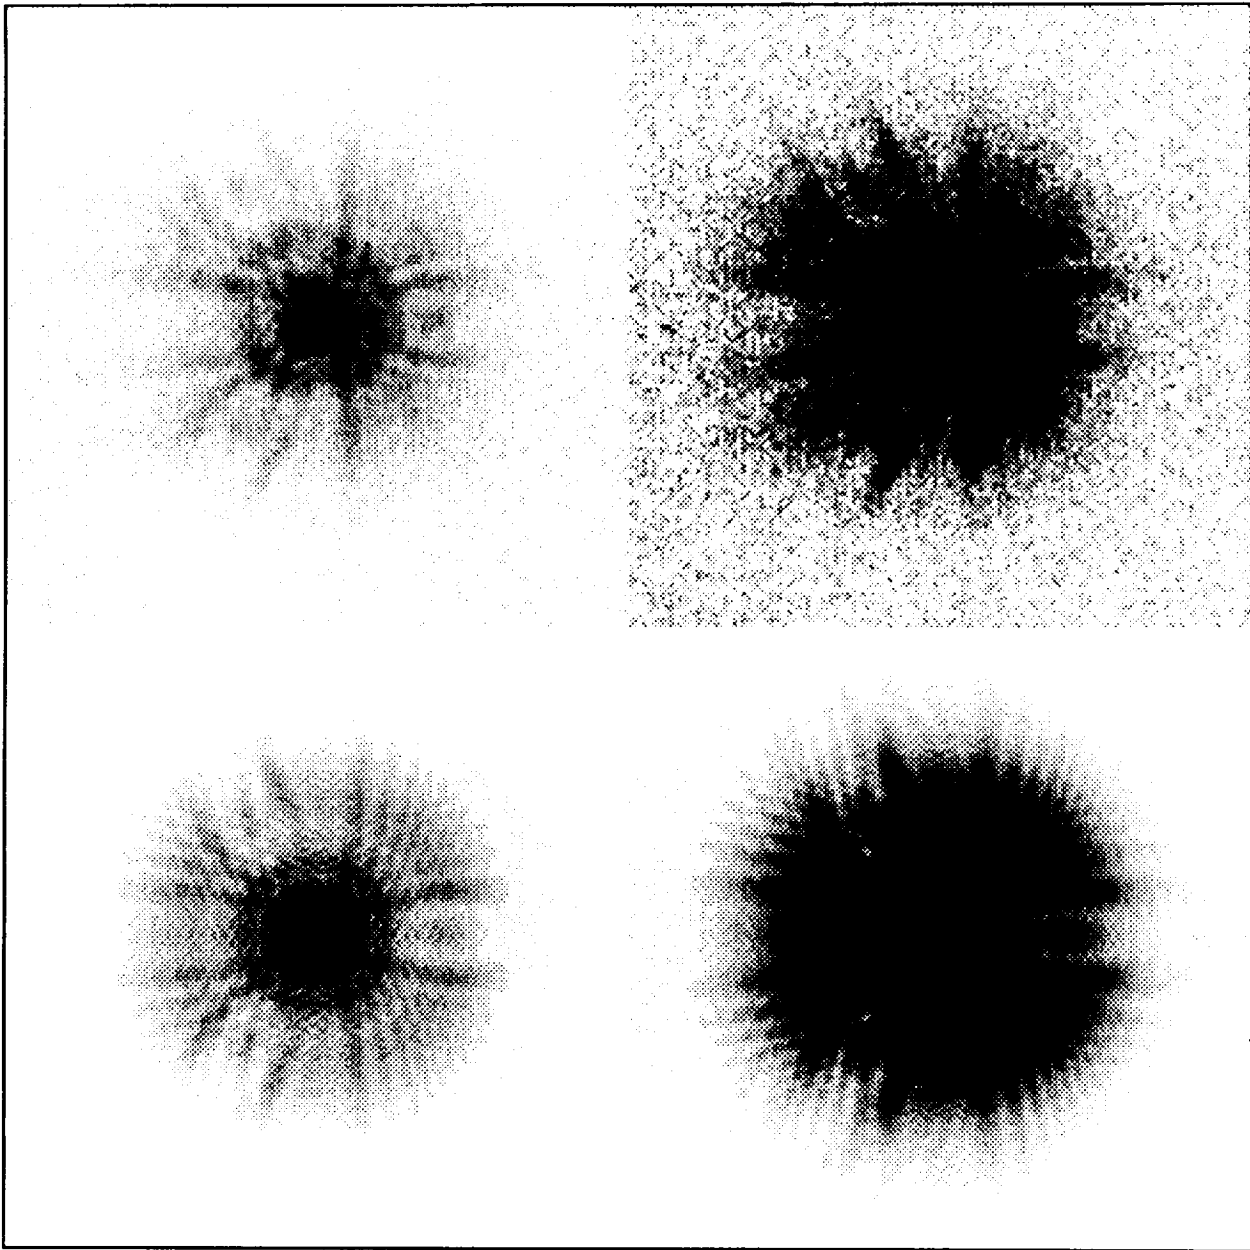
After a position for the secondary mirror was selected for first light, the Wide Field/Planetary Camera (WF/PC) recorded its first image. The initial image analysis indicated significant defects. Since the secondary mirror had only been moved along the axis of symmetry, it was still believed at the time that corrections could be made by tilting or decentering the mirror to improve the focus.

Corrections to the imaging defects due to misalignment were attempted by tilting and decentering the secondary mirror, but these adjustments did not improve the wavefront or the image quality. Further analysis and computer simulation of the WF/PC images indicated that 0.5-wave rms wavefront spherical aberration at 547 nm (equivalent to 0.43-wave rms wavefront error at 632.8 nm) existed in the telescope (Figure 6-1). When interferograms taken by the WFS also indicated severe spherical aberration, the HST Project Manager was notified, and the Contingency Plan was put into effect.

**(a) Recorded image of the PC5 star taken on June 14, 1990, with a 0- $\mu$ m inside focus.**

**Figure 6-1. Planetary Camera images versus computer simulations. The images in the top frames were taken with the Planetary Camera; those in the bottom frames are computer simulations created using an optical model with 0.5-wave rms wavefront error at 547 nm.**

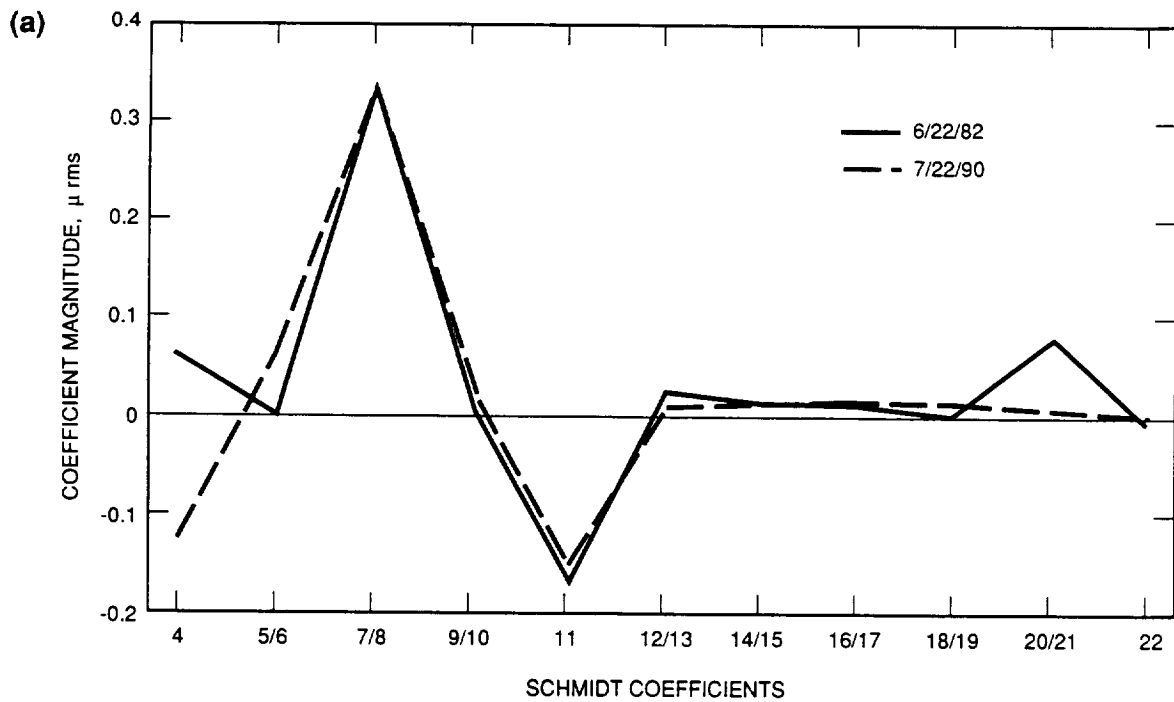
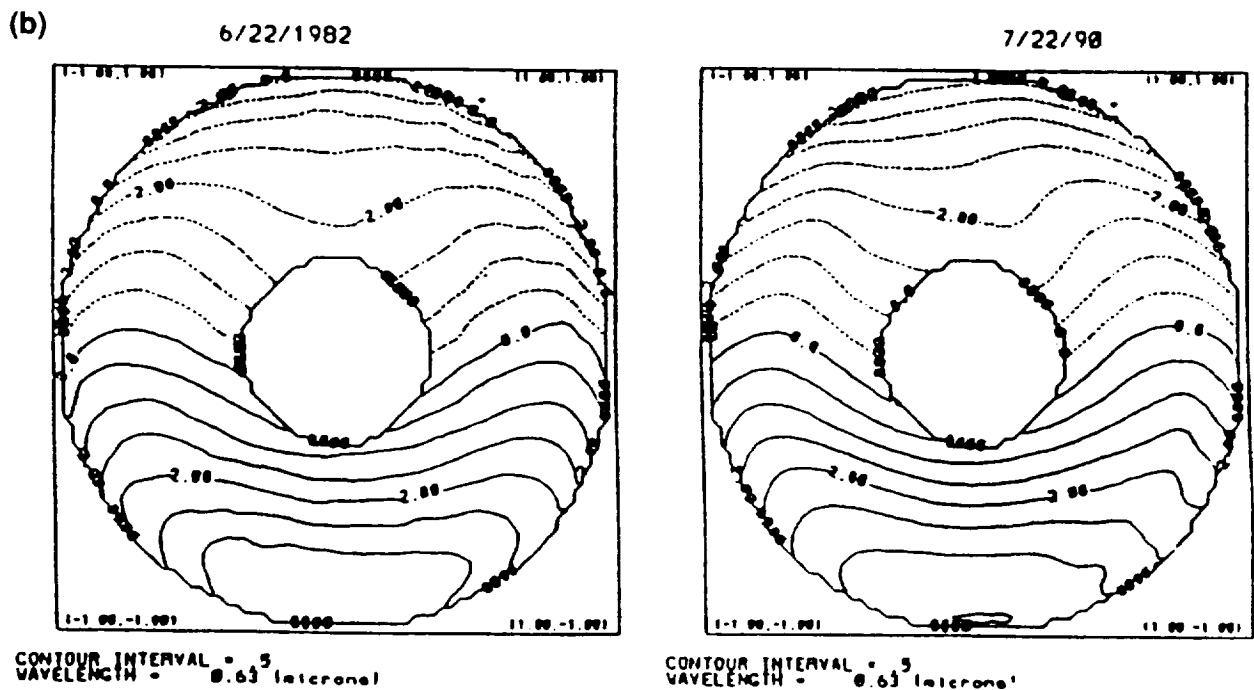
The first test performed on the RNC was to insert the INC and take an interferogram on July 22, 1990. This interferogram was analyzed and compared with a previous interferogram taken with the INC in place. (This latter interferogram was found in a notebook of a P-E employee and was dated June 22, 1982.) Comparison of these two interferograms (Figure 6-2) shows virtually identical results, clearly indicating the existence of spherical aberration. These INC interferograms are corroborated by the RvNC interferograms, which also show spherical aberration (as discussed in Appendix D, Figure D-2). The combination of these interferograms led the Board to conclude that the CORI/RNC assembly is now essentially in the same state of operation as it was at the time the final measurements were made on the primary mirror.

Unverifiable testimony raised the possibility of a waiver having been granted for an optical spacing error in the INC. During the current investigation, an error in the design calculations was discovered that produced a small amount of spherical aberration in the INC. An analysis of the "as-built" INC conducted for the investigation showed that the instrument had an accuracy to better than 0.14 wave.

Figure 6-2. Comparison of 1982 and 1990 inverse null corrector data. (a) The coefficients which define the magnitude of various distortions to the wavefront were measured by the INC when it was inserted in front of the RNC in 1982 and in 1990. (b) The coefficient data were extracted from these plots of the interferograms.

The amount of spherical aberration introduced by the INC error is only a small amount compared to the amount of spherical aberration actually measured.

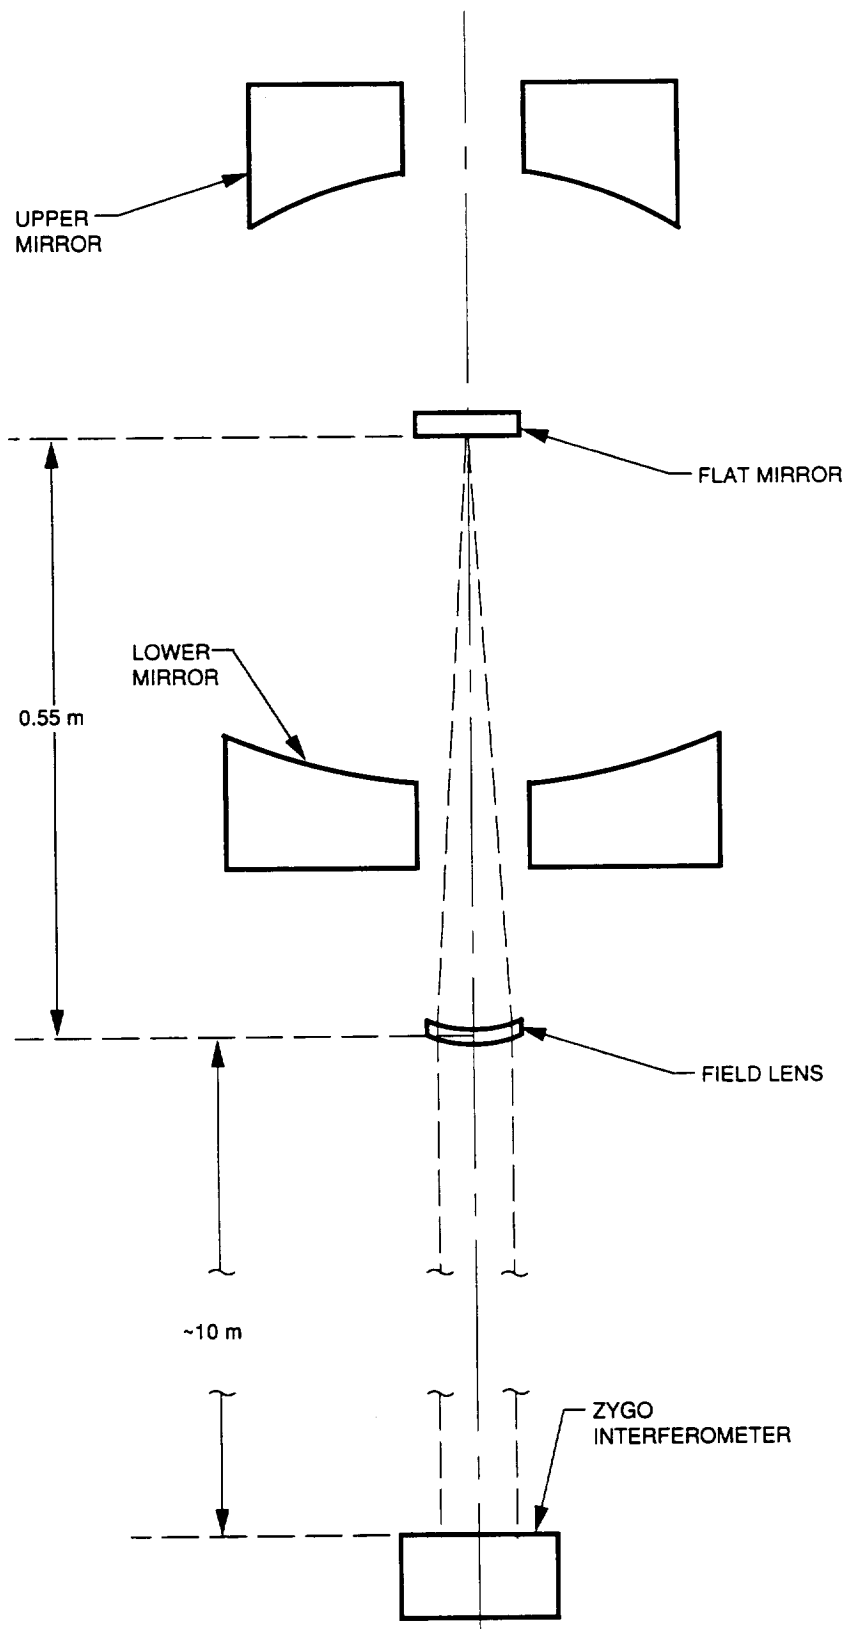
The optical element spacing was measured in 1990 by shining collimated light up through the field lens using a Zygo interferometer as the source, and by placing a flat mirror at the focus of the field lens (a distance of about 0.55 m above the lens). The correct position of the mirror was determined by using the interferometer to find the best focus (Figure 6-3). The distance from the flat mirror was then measured down to the vertex of the lower mirror using a fixture in the mirror hole for a reference. This measurement showed that the field lens was about 1.3 mm too far from the lower mirror. Both the direction and the magnitude of the spacing error correctly explained the spherical aberration observed in the HST image data. The spacings of the other optical elements in the RNC were measured and were found to be correct.

**Figure 6-3. The 1990 spacing measurement between the field lens and the lower mirror of the reflective null corrector, using an optical test.**

In addition to the optical test used to detect the field-lens spacing error, a direct physical measurement was made from the field lens to the vertex of the lower mirror (Figure 6-4). A lightweight spacing rod and a new vertex plug were made. The results verified the previously measured spacing error to  $\pm 0.1$  mm. More accurate measurements of the displacement error will be done at a later time, as this information is necessary for an accurate determination of a prescription for the recovery optics.

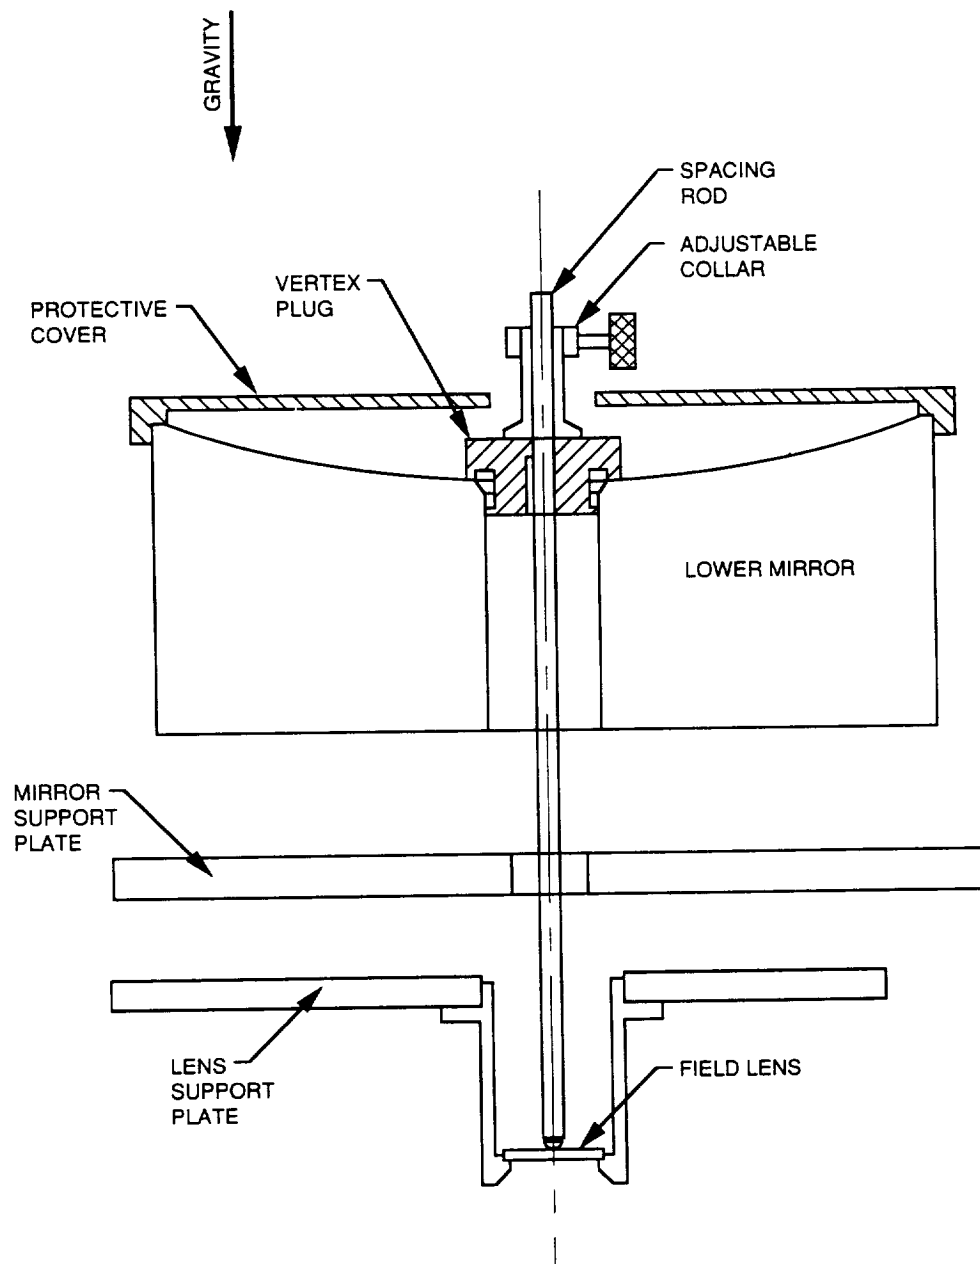
When the field lens position error (FLPE) is taken into account and applied in correcting the data taken with the RNC, it results in a mirror shape that would account for most of the error observed in the HST images. Also, the interferograms taken with the RvNC were reprocessed and corrected for the as-built data available for the RvNC. This independent set of data yields a mirror shape very close in value to the RNC/FLPE data. These data led the Board to conclude that the predominant source of error had been found and was caused by the field lens position error. (See Appendix E for the HST performance based on the as-built data.)

**Figure 6-4. The 1990 spacing measurement between the lower mirror vertex and the field lens of the reflective null corrector, using a mechanical technique.**

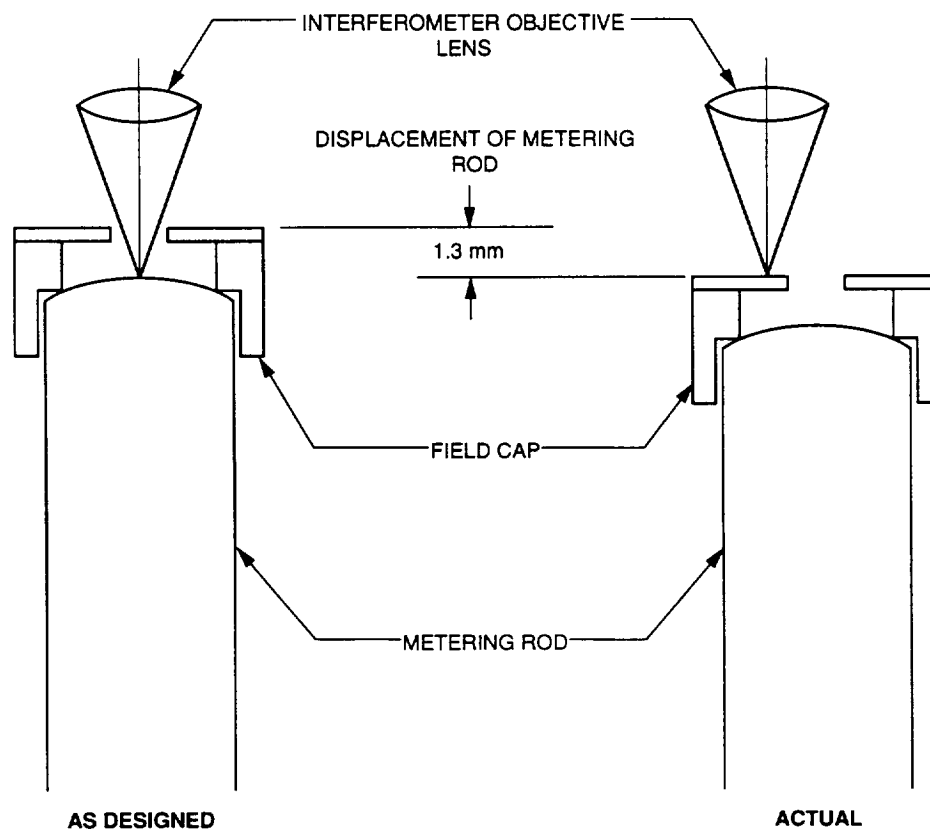
It has been established that the field lens was approximately 1.3 mm too far from the lower mirror of the RNC, which was used to figure the primary mirror. The RNC and its associated interferometer were found in the test chamber, unused and unchanged since the completion of the HST program. The RNC was measured in situ, and there is high confidence that the spacing error existed during the fabrication and test of the HST primary mirror. The cause of the spacing error, on the other hand, becomes a matter of conjecture, because the records necessary to reproduce what actually happened were not found. The scenario given below reproduces the events and provides a rationale of how the spacing error occurred. This scenario was simulated in the laboratory under the guidance of the Board and is the most likely cause of the error.

With one end of the metering rod presumably located at the center of curvature of the lower RNC mirror, the field lens was then brought up to the end of rod B, but there was no adjustment left in the screws used for this positioning. More adjustment room was made by inserting spacers between the field lens and the lower mirror mounting plate. The adjustment mechanism was found not to be staked. Staking, i.e., securing the mechanism to prevent inadvertent movement, was a specified procedure. The final location of the field lens was then set with the addition of the spacers. As a result, the field lens was about 1.3 mm too far from its correct position relative to the lower mirror.

**Figure 7-4. Displacement due to the interferometer focusing on the field cap instead of the metering rod.**

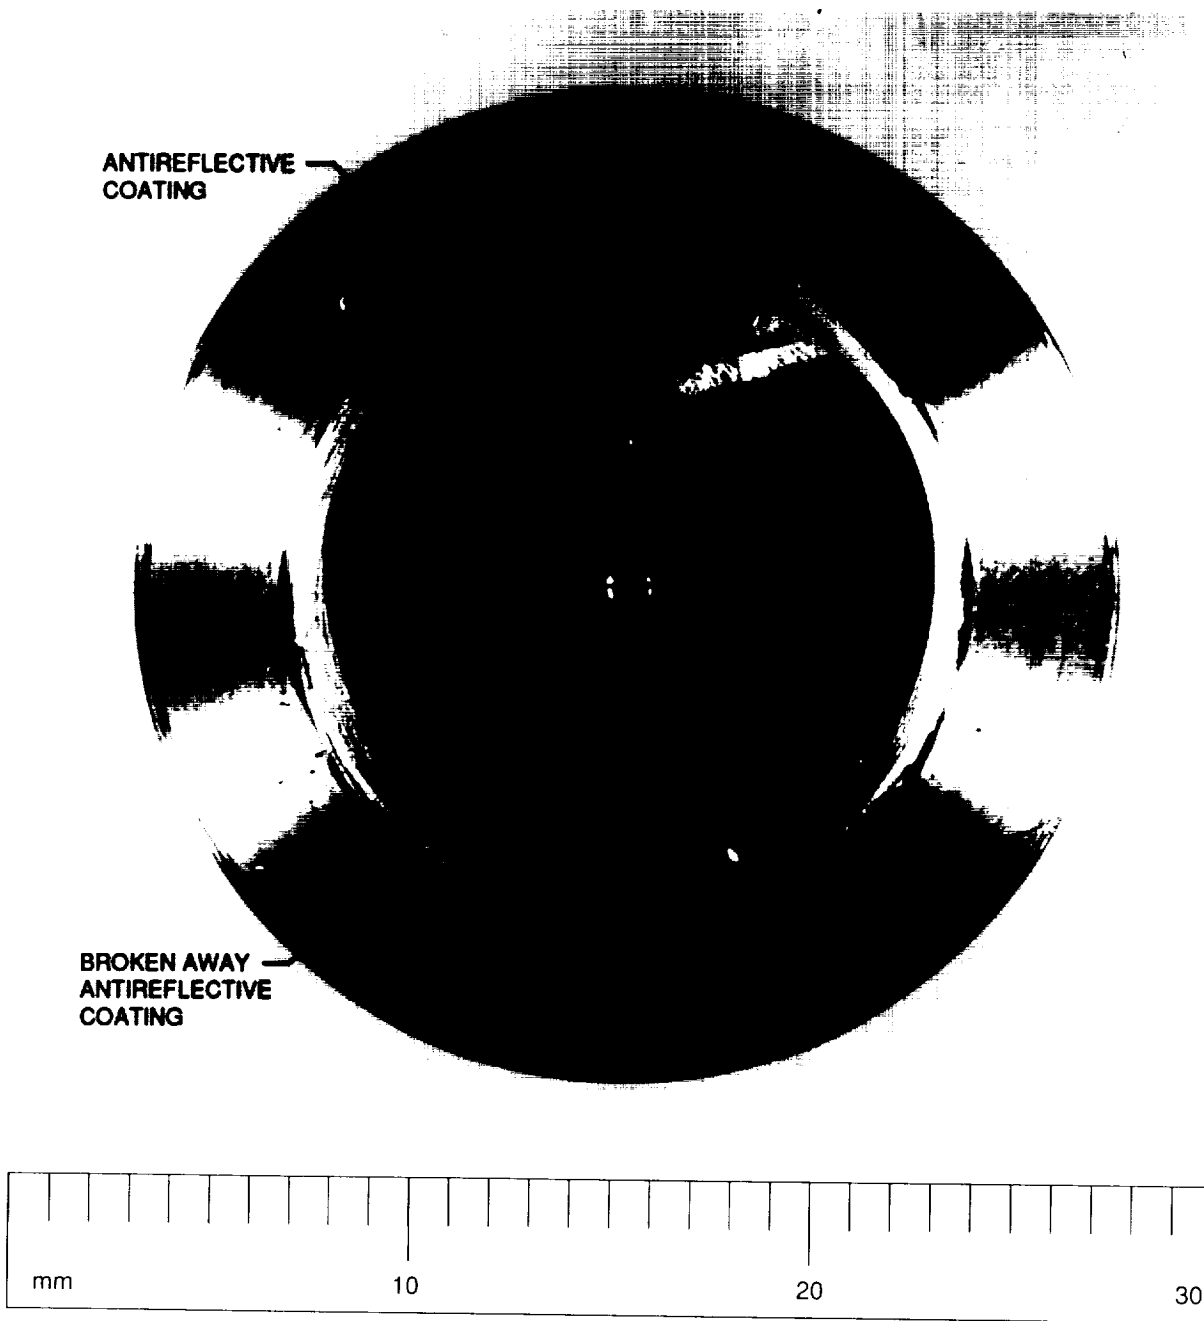
The top surface of the field cap was covered with nonreflecting material; however, some of this material had, apparently inadvertently, broken away from a small area around the field cap aperture. It appears that the operator obtained reflection from the field cap where the nonreflecting material was absent, rather than the rod end, causing the 1.3-mm misspacing. A test performed in 1990 with the equipment showed that it was quite easy, even probable, to make this error with the configuration used. Figure 7-4 indicates how the displacement error occurred by reflecting light off the field cap, rather than the rod end, as designed. Figure 7-5 is a photograph of the field cap and shows the specular region around the aperture. (In this photograph, the broken-away coating appears darker than the surrounding region.)

**Figure 7-5. Top view of the field cap, showing the aperture and the area where the antireflective coating had broken away.**

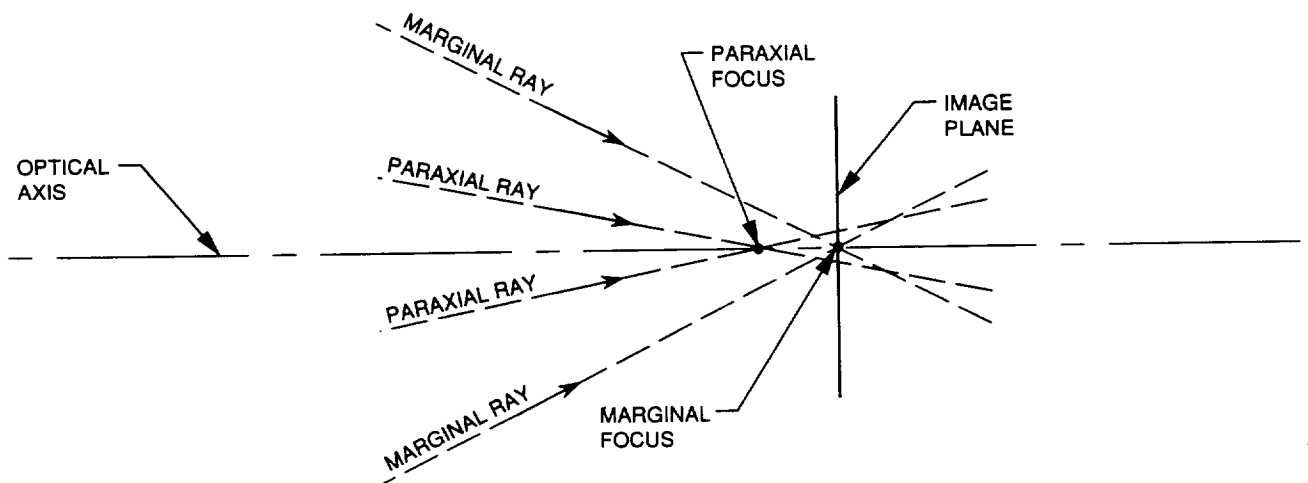
In the case of the HST, the "template" (the reflective null corrector) used to provide the reference surface for figuring the primary mirror, was not correct. In Figure C-4, we show an enlarged view of the marginal and paraxial rays as they converge in the vicinity of the vertex of the HST. Figure C-1 was used to show how the marginal focus could be superimposed on the paraxial focus by removing material. In the HST, too much material was removed from the outer edges of the primary mirror, and the marginal focus was moved to the right, past the paraxial focus. Since the marginal focus is to the right of the paraxial focus, the sign on the error is negative. Since more material than necessary was removed, the opticians call this situation "overcorrected" spherical aberration.

**Figure C-4. Image-plane enlargement of the HST Ritchey-Chretien optical system. In the HST, too much material from the edges of the primary mirror was removed, and the marginal focus was moved past the paraxial focus. This is characteristic of an optical system overcorrected for spherical aberration.**

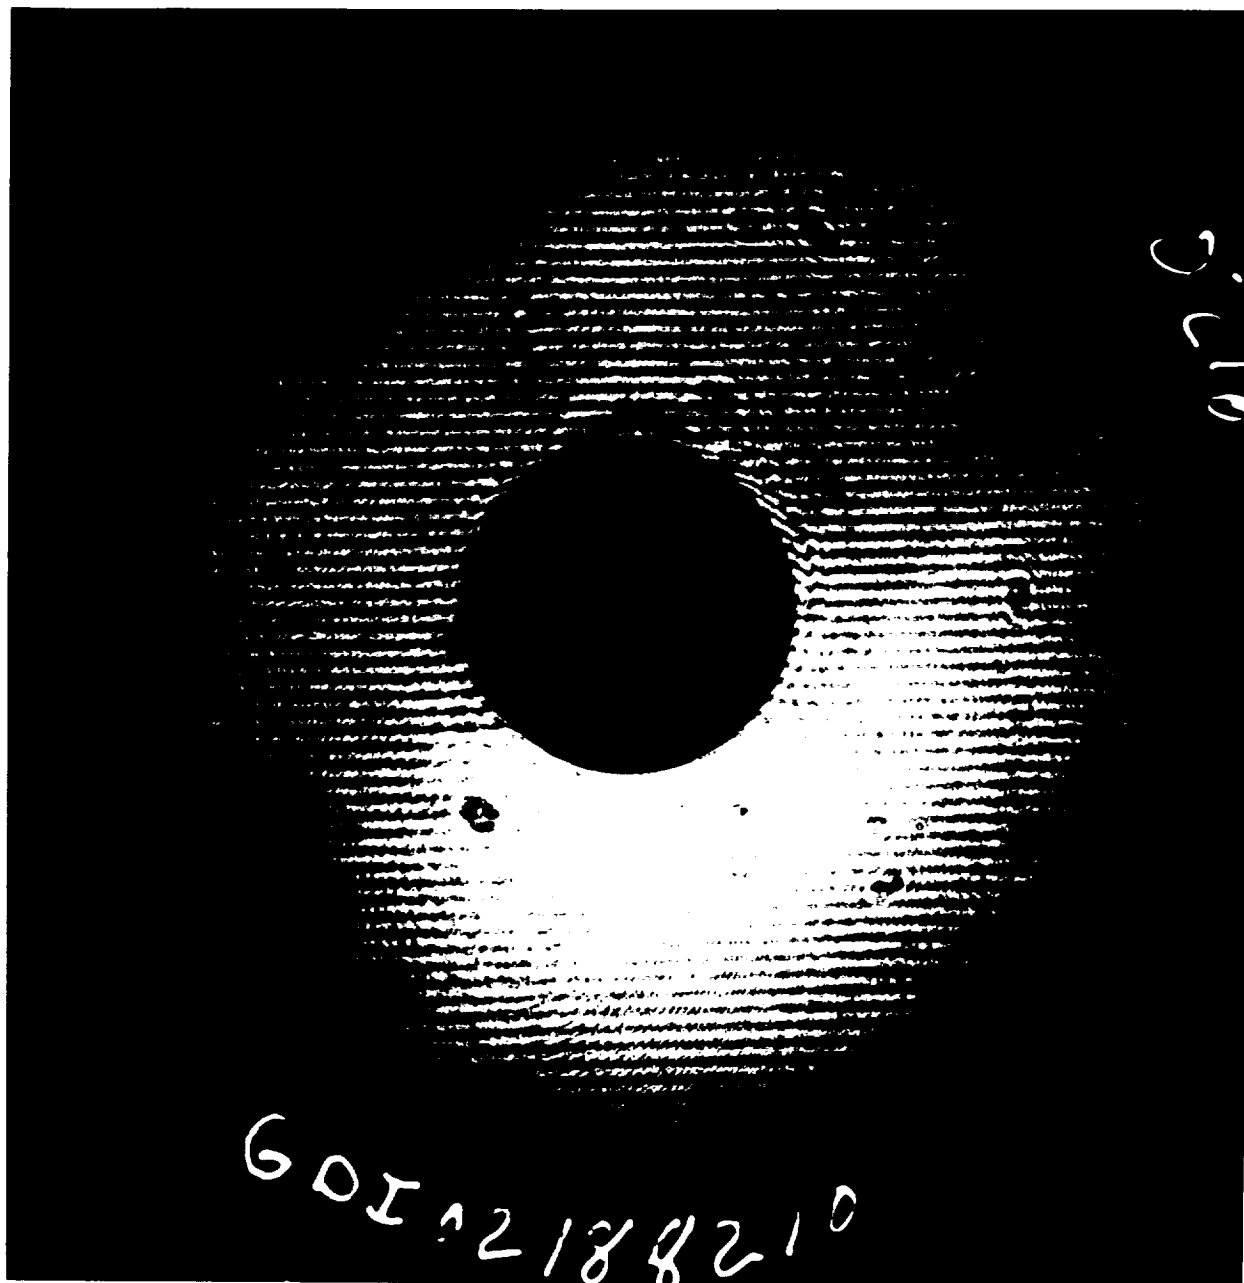
This interferogram shows three circular obscurations that cover penetration holes in the mirror surface. The obscurations were not directly part of the mirror support system, but they covered catch plates that would keep the mirror from breaking loose of the mount and damaging portions of the space shuttle orbiter, should the shuttle have had to abort the flight and return to Earth in an emergency landing. The fringe pattern also indicates the presence of local, sharp surface errors that actually fall outside of the clear aperture being used in the telescope. The semicircular marks at the periphery are fiducials used to locate the aperture in the fringe digitization process. The other defects indicated in the picture are glass chips and marks attached to components in the reflective null corrector.

Figure D-1. RNC interferogram of the primary mirror, taken in February 1982.
