# The Hubble Space Telescope Optical Systems Failure Report

November 1990

National Aeronautics and  
Space Administration

**THE HUBBLE SPACE TELESCOPE**  
**OPTICAL SYSTEMS FAILURE REPORT**

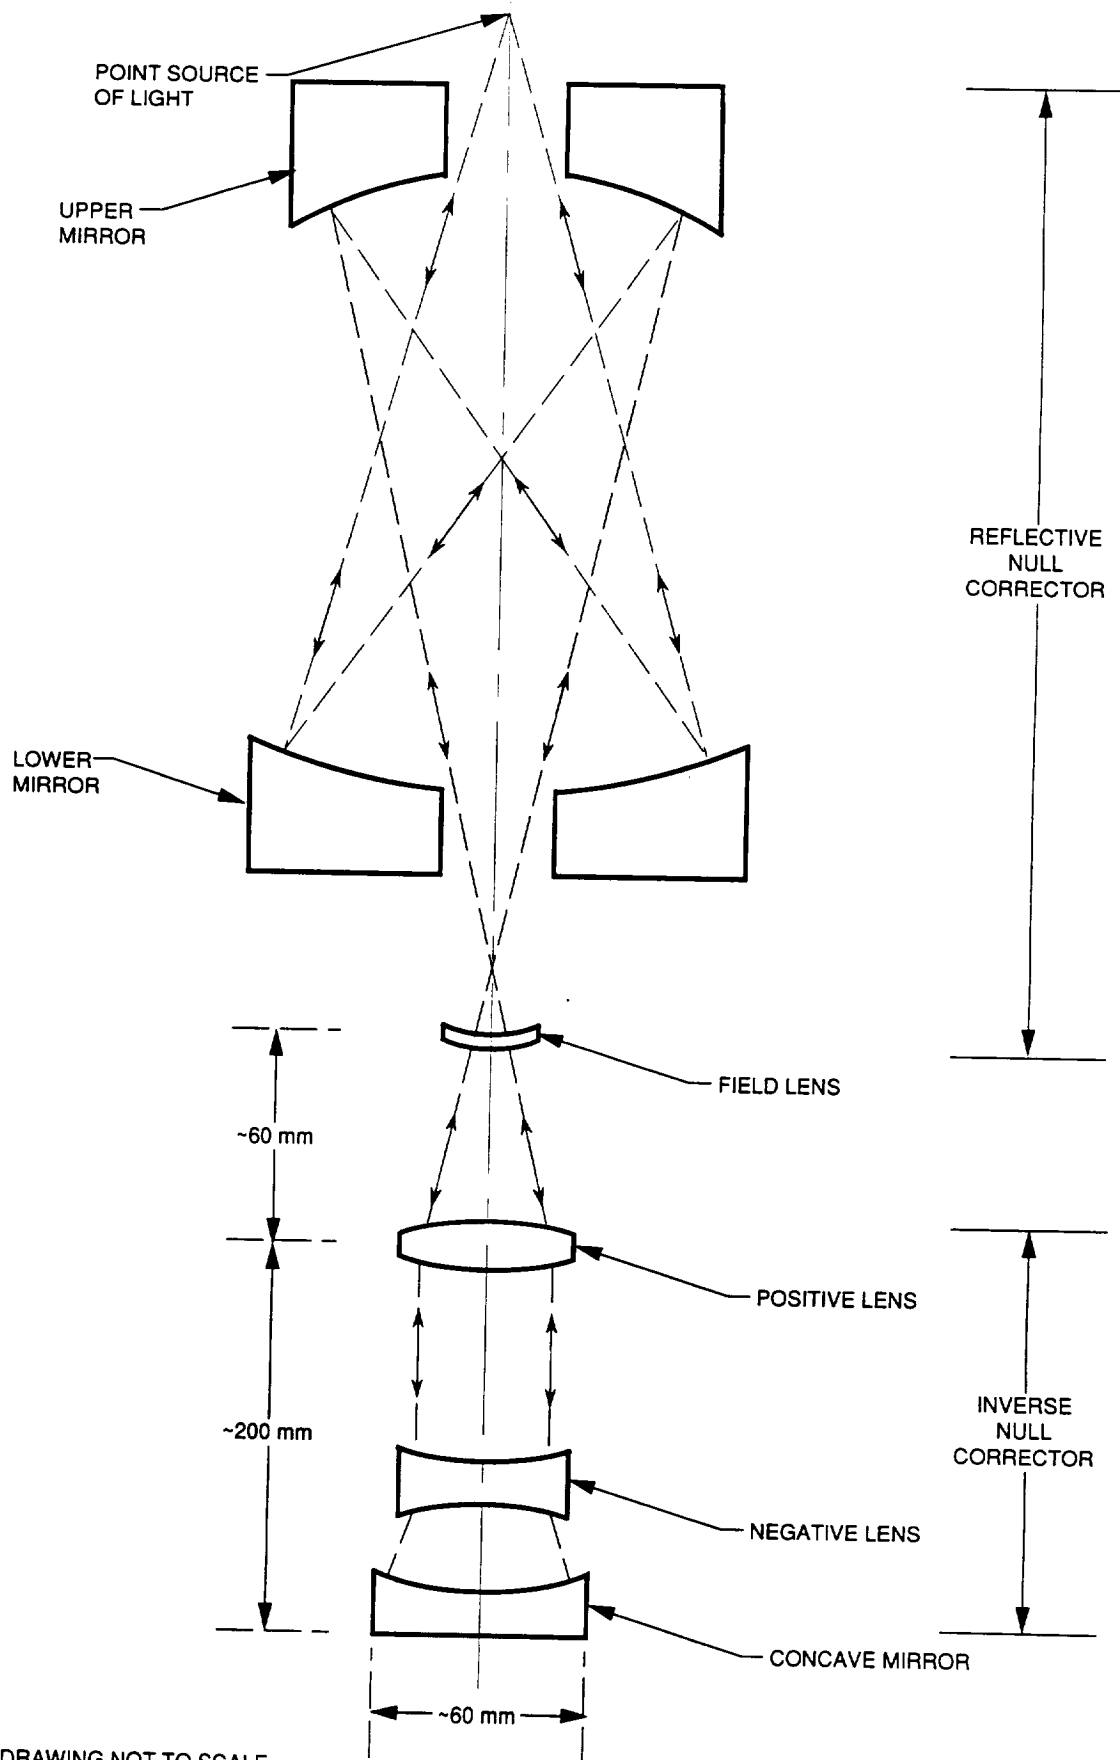
**Figure 4-3. Inverse null corrector inserted below the reflective null corrector.**

As a check on the position of the Coaxial Reference Interferometer (CORI) used with the RNC, an inverse null corrector (INC) was designed. When swung under the RNC, the INC would simulate a perfect mirror, just as a perfect primary mirror would appear with straight fringes when viewed through the RNC (Figure 4-3).

The actual use of the INC during testing was as an aid in alignment of the RNC system, and the INC was swung into position below the RNC at the beginning and end of each test sequence. The technicians used the INC fringes as a qualitative check upon the condition and alignment of the RNC, but the fringe pattern was apparently not fully evaluated at any time during the test period. It was known that the components of the INC were very sensitive to alignment, and also that there was a probable spacing error in the INC. Subsequent analysis has indicated that this error is of small magnitude.

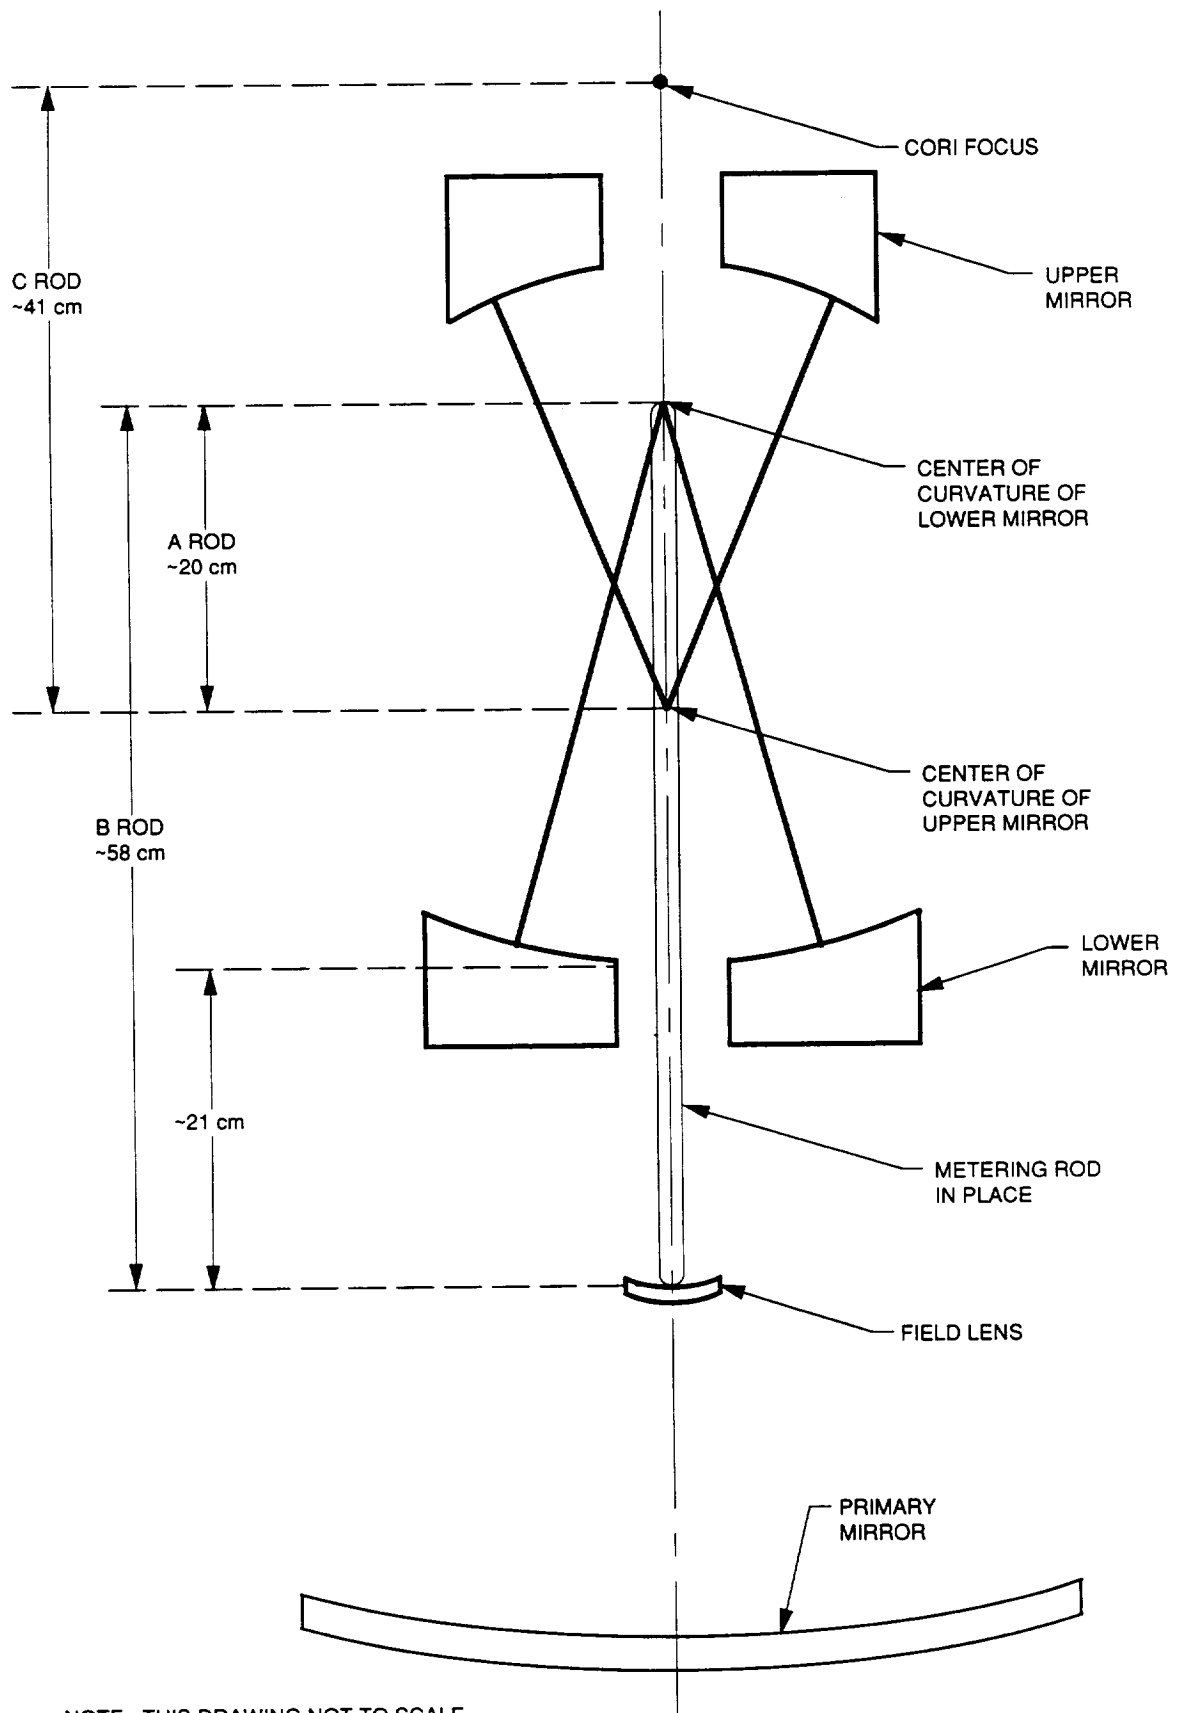
**Figure 7-1. Position of metering rods used to space optical elements in the reflective null corrector.**

At the beginning of the program to build the 2.4-m Hubble primary mirror, P-E modified the RNC that had been used in building a 1.5-m mirror prototype. This modification required adding a new field lens and respacing the optical elements to create the correct shape for the larger mirror. Figure 7-1 is a schematic of this RNC, including the positions of the metering rods used to set the optics.

There were three metering rods (labeled A, B, and C) made of Invar, a metal with a small temperature expansion coefficient. The ends of the metering rods were rounded and polished because the very precise positioning of the optics in the RNC used an interferometer, rather than a mechanical measurement. This procedure involved auto-reflecting a focused beam of light off the end of a rod and observing an interference pattern from the beam that came back on itself. Centering the light beam on the rod end was essential for the measurement. To prevent the metering rod from being misaligned laterally with respect to the interferometer axis, P-E decided to attach "field caps" to one end of the rod (Figures 7-2 and 7-3). The field caps were fitted over the rod ends and had a small aperture in the center to ensure centering of the rod on the beam.

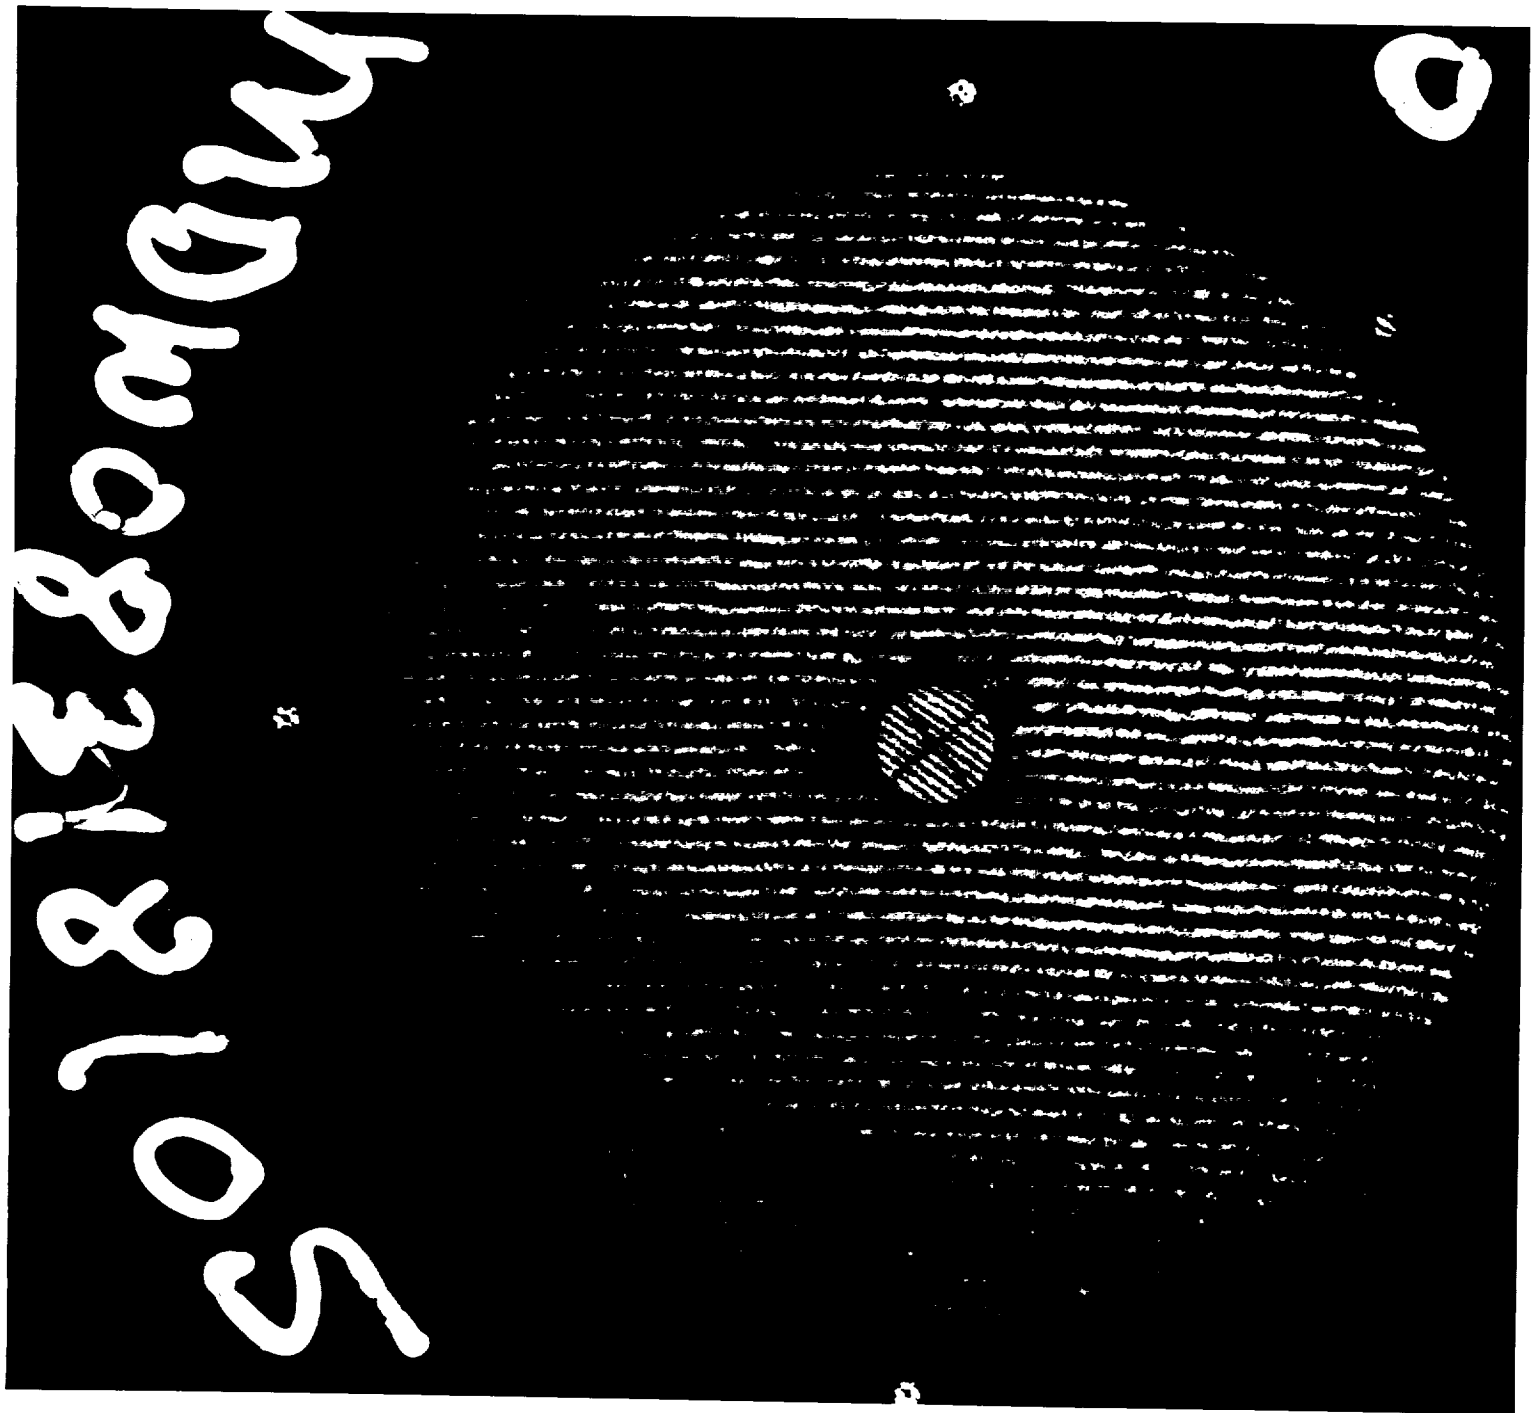
Figure D-4. Hindle Shell interferogram of the secondary mirror, taken August 31, 1981.

Analysis of this interferogram in 1990 supports, with only minor differences, the predicted quality of the surface shape.
